MILL CREEK PASSAGE GOSE STREET CONCEPTUAL DESIGN

PROJECT # 21-1010

DRAFT - BASIS OF DESIGN REPORT

Geomorphic Assessment of the Gose Street Reach of Mill Creek near Walla Walla, Washington

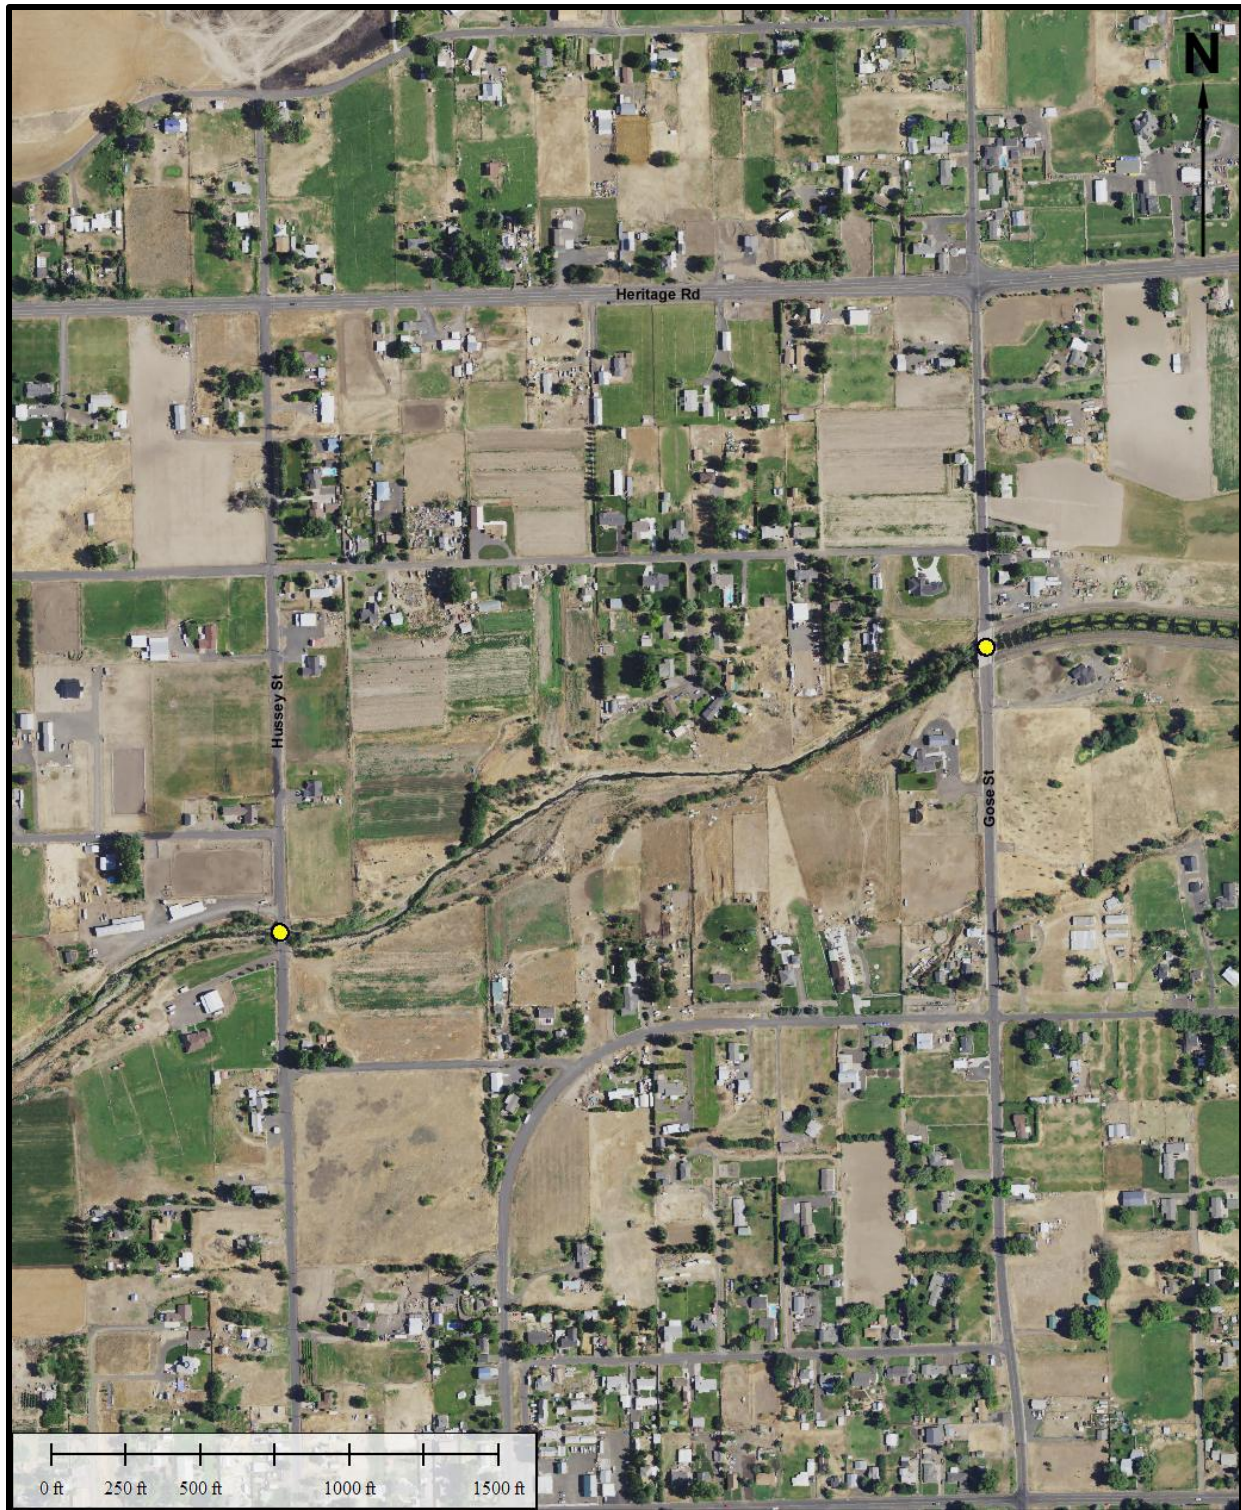
2021 USDA NAIP orthophotograph; Gose and Hussey Street crossings of Mill Creek are highlighted with yellow dots.

Figure 1. Current conditions in the Gose Street reach of Mill Creek.

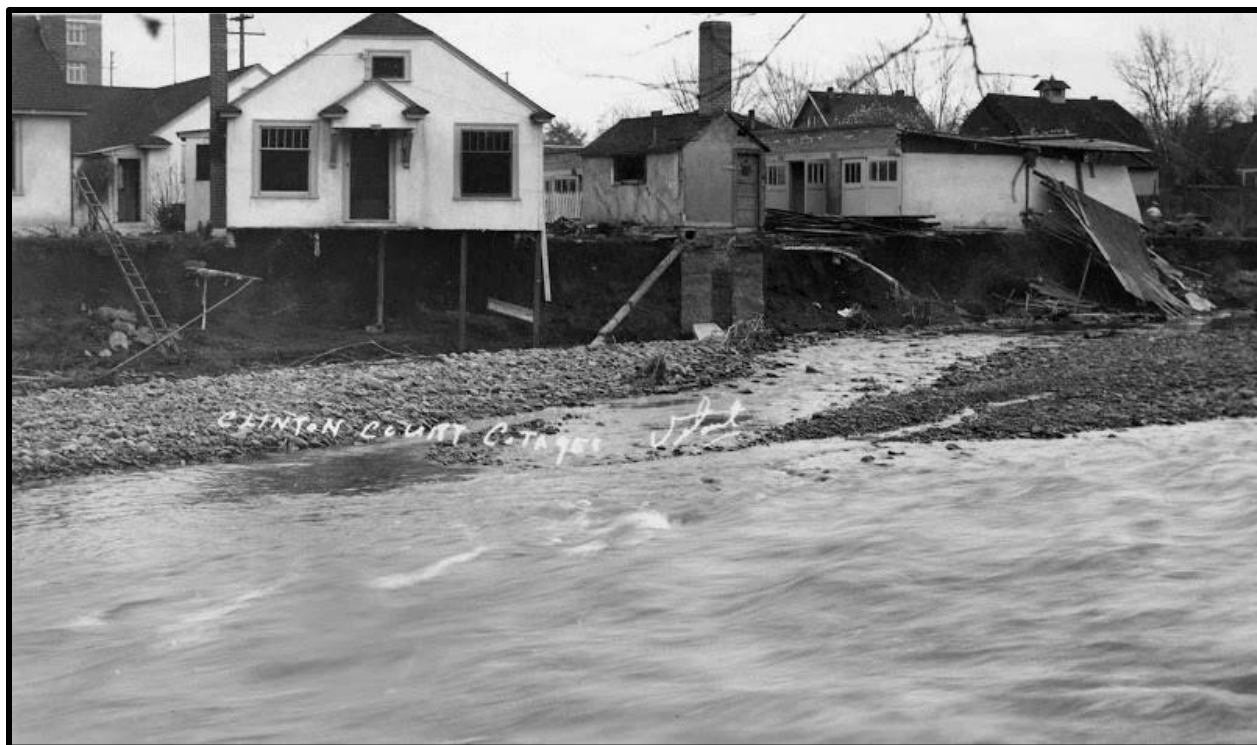
Figure 12. Flood damage and sediment accumulation in the town of Walla Walla following the 1931 Mill Creek flood.

One of the largest floods on record in Mill Creek occurred from March 31 to April 2, 1931 and would be the impetus for local stakeholders and the U.S. Army Corps of Engineers to complete the Mill Creek flood control project more than a decade later. The flood was caused by a rain-on-snow event in early spring that involved significant precipitation (an estimated 6.65 inches) combined with snowmelt from warm winds that can produce substantial amounts of runoff over a short period of time. Again, no streamflow measurements were available to record the peak discharge. The cleanup took six months to complete and involved hauling away tons of debris and silt (Figure 12). A dredge was brought in to clear obstacles and excavate sediment from Mill Creek.

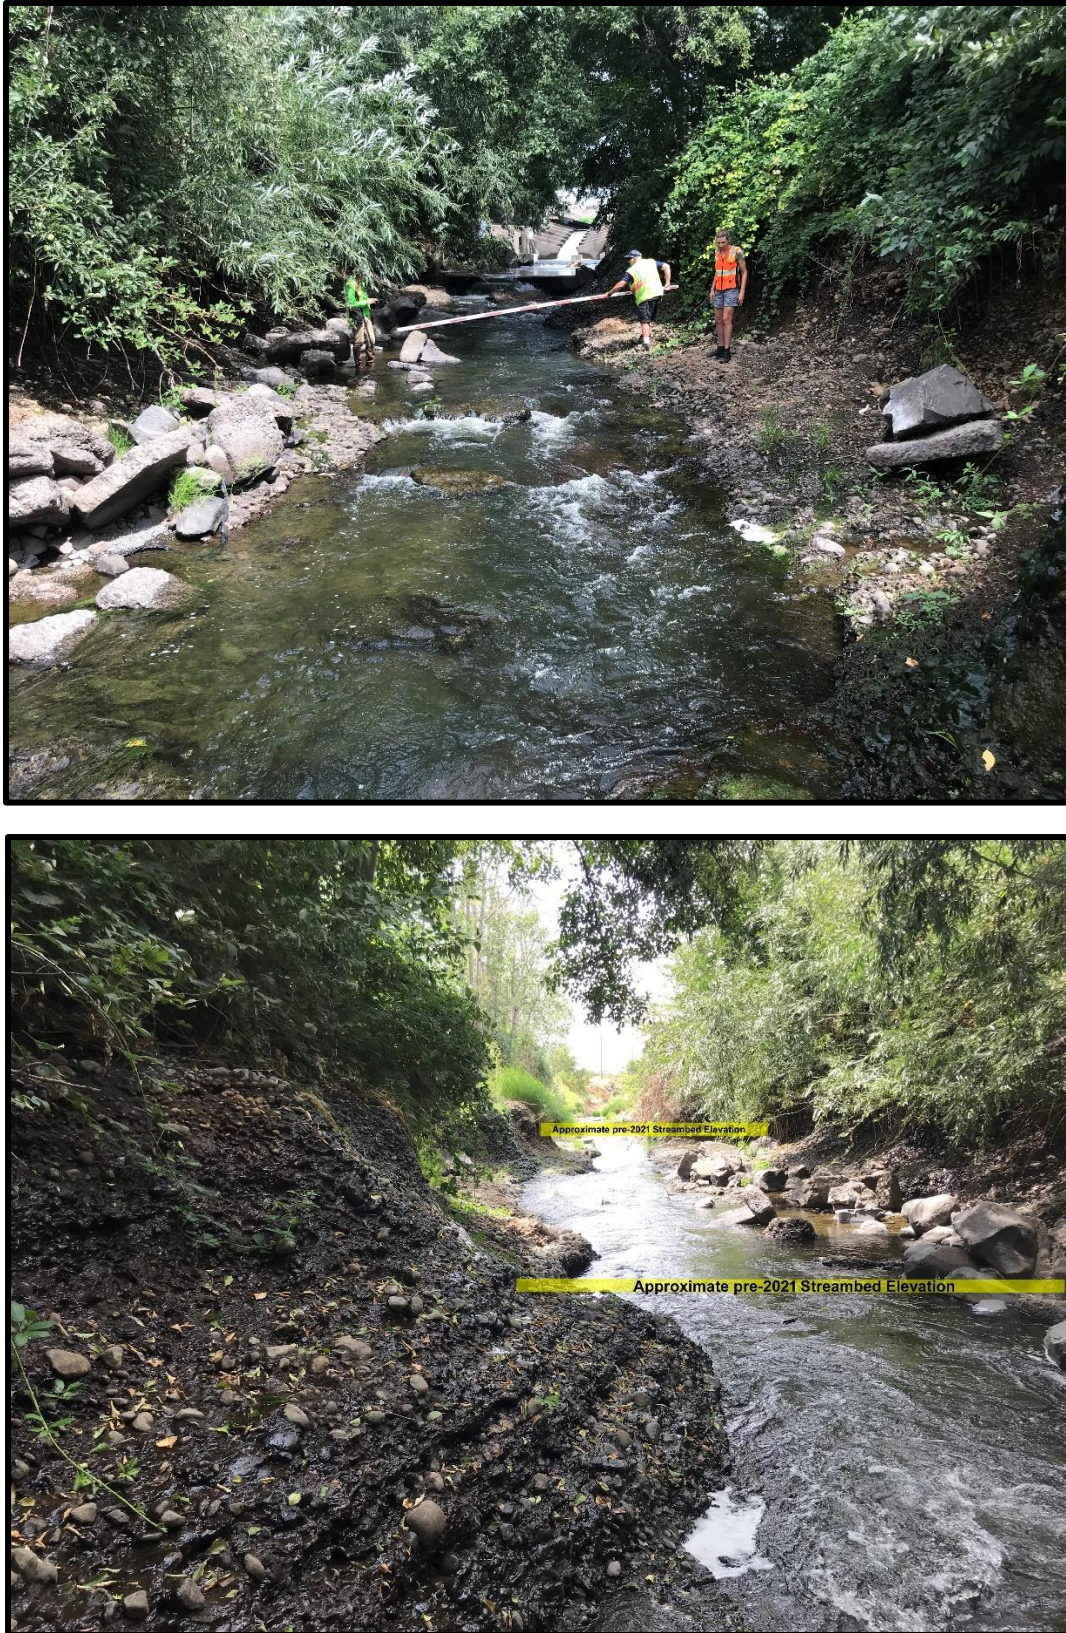
Figure 15. Mill Creek looking upstream and downstream below the concrete fishway.

The current Mill Creek channel below the concrete fishway is tightly confined by cemented conglomerate banks about 20 feet in height (Figure 15). The top of the steep banks is well vegetated with a dense canopy cover along the first 300 feet of the stream below the fishway. The vegetation includes willow and blackberry shrubs. The channel bed is composed of cemented conglomerate and contains very little loose substrate. Chunks of conglomerate, old rip-rap, and concrete have been deposited along the edge of the channel. Portions of the north bank have been undercut by several feet (Figure 16). Lenses of sand and silt in the conglomerate stratigraphy may be preferentially prone to erosion and lead to the undercut banks. Small groundwater seeps were also observed along the south bank of the stream. The channel remains tightly confined for another 400 feet beyond the denser vegetation and is generally unshaded by an overstory canopy. The banks are dominated by grasses and patches of reed canary grass.

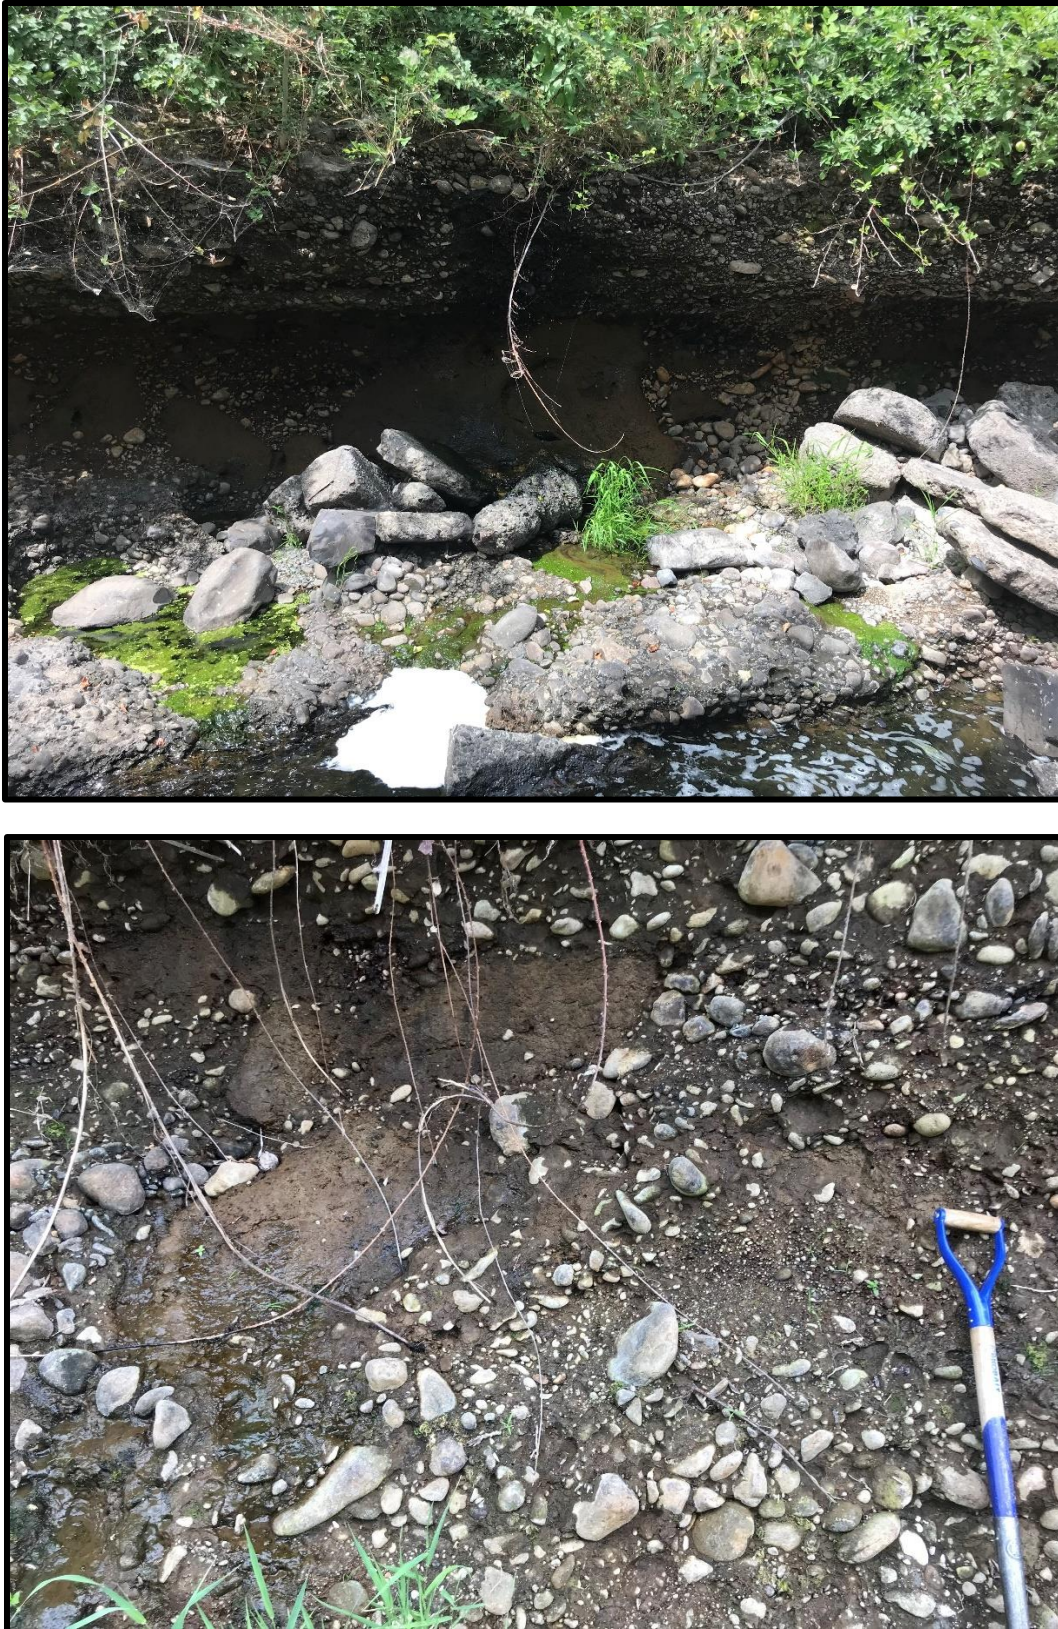
Figure 16. Undercut banks and lenses of sand and silt within the conglomerate of Mill Creek.

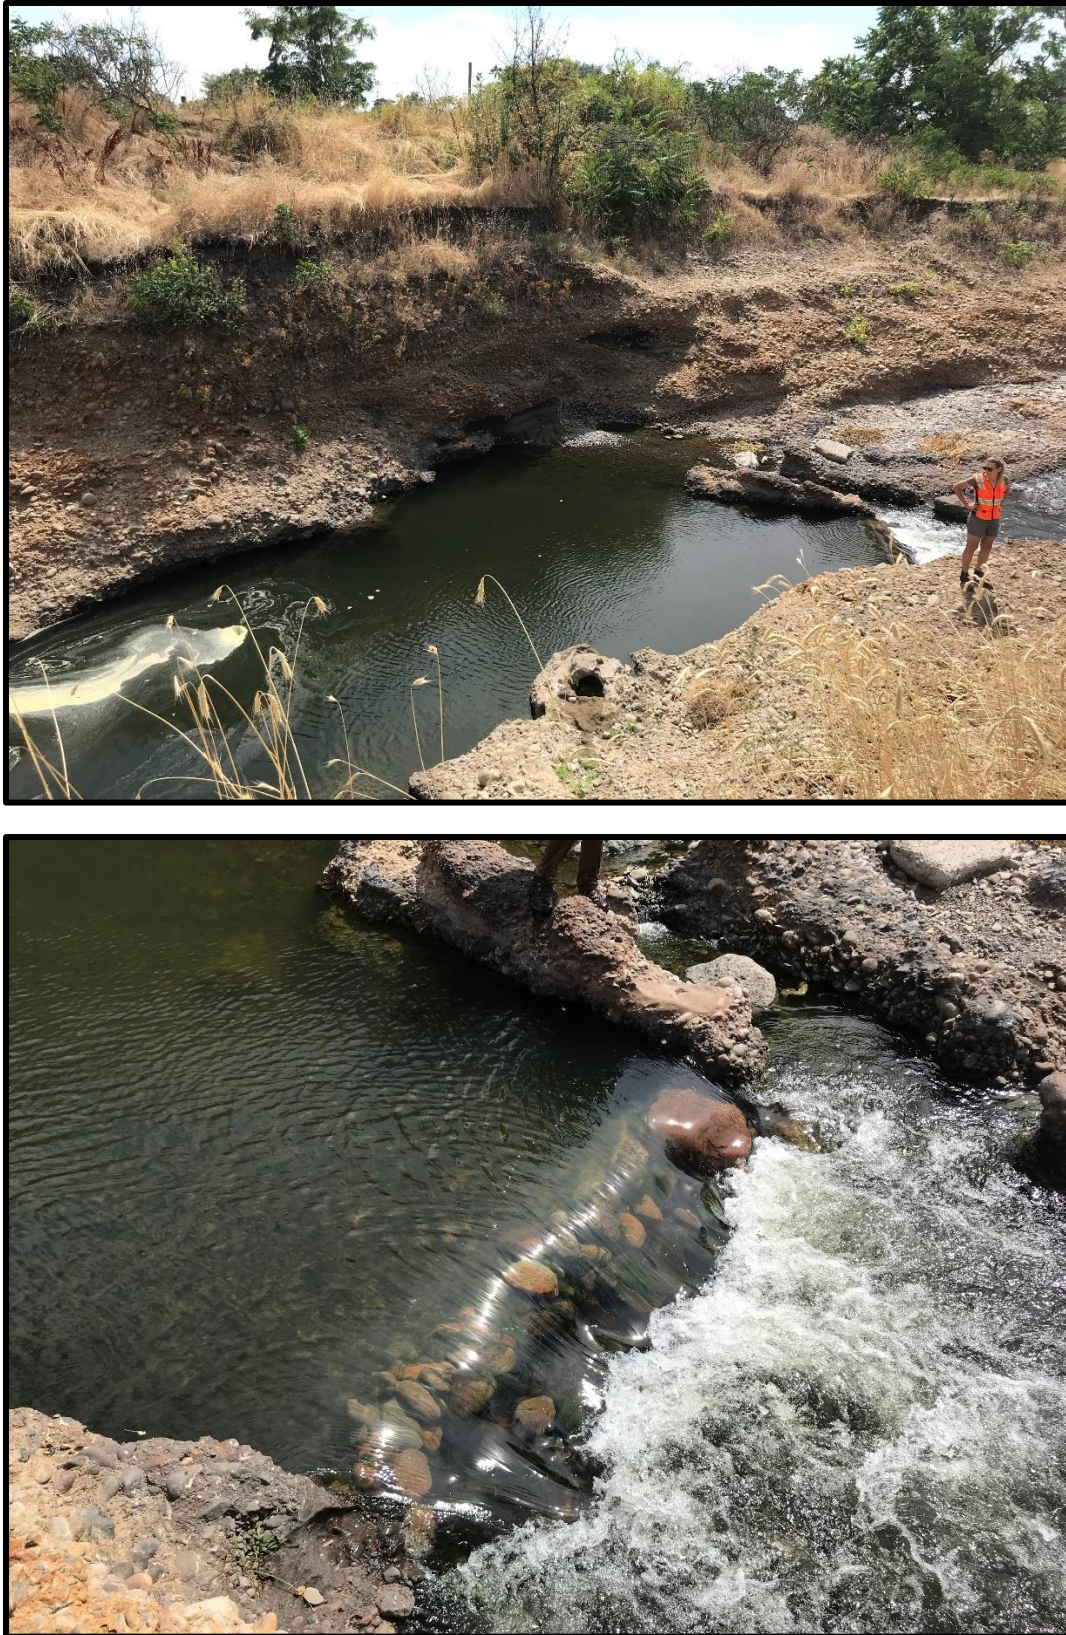
Figure 17. Start of wider channel area and resistant conglomerate knickpoint on Mill Creek.

As Mill Creek bends to the west, the channel and floodplain area widen, but the channel remains tightly confined by the conglomerate banks (Figure 17). A narrow band of more resistant conglomerate may be responsible for the small knickpoint with a 2- to 3-foot drop into the plunge pool below or it may represent a mobile knickpoint as channel incision propagates upstream. The channel narrows beyond the pool area and bends to the southwest before approaching the Hussey Street crossing. Most of the channel area is unvegetated with only grass and small shrubs on the banks of the stream. The banks are about 15 feet high and still largely composed of cemented conglomerate. The top 3 to 5 feet of the bank consists of rounded gravel and cobble along with sand and silt from younger alluvial deposits. The younger alluvial deposits are unconsolidated and do not show the oxidation and weathering seen in the clasts of the older cemented conglomerate. (Figure 18). The former floodplain on the north bank now consists of residential development and shows the extent to which the former floodplain has been disconnected from high flows in Mill Creek.

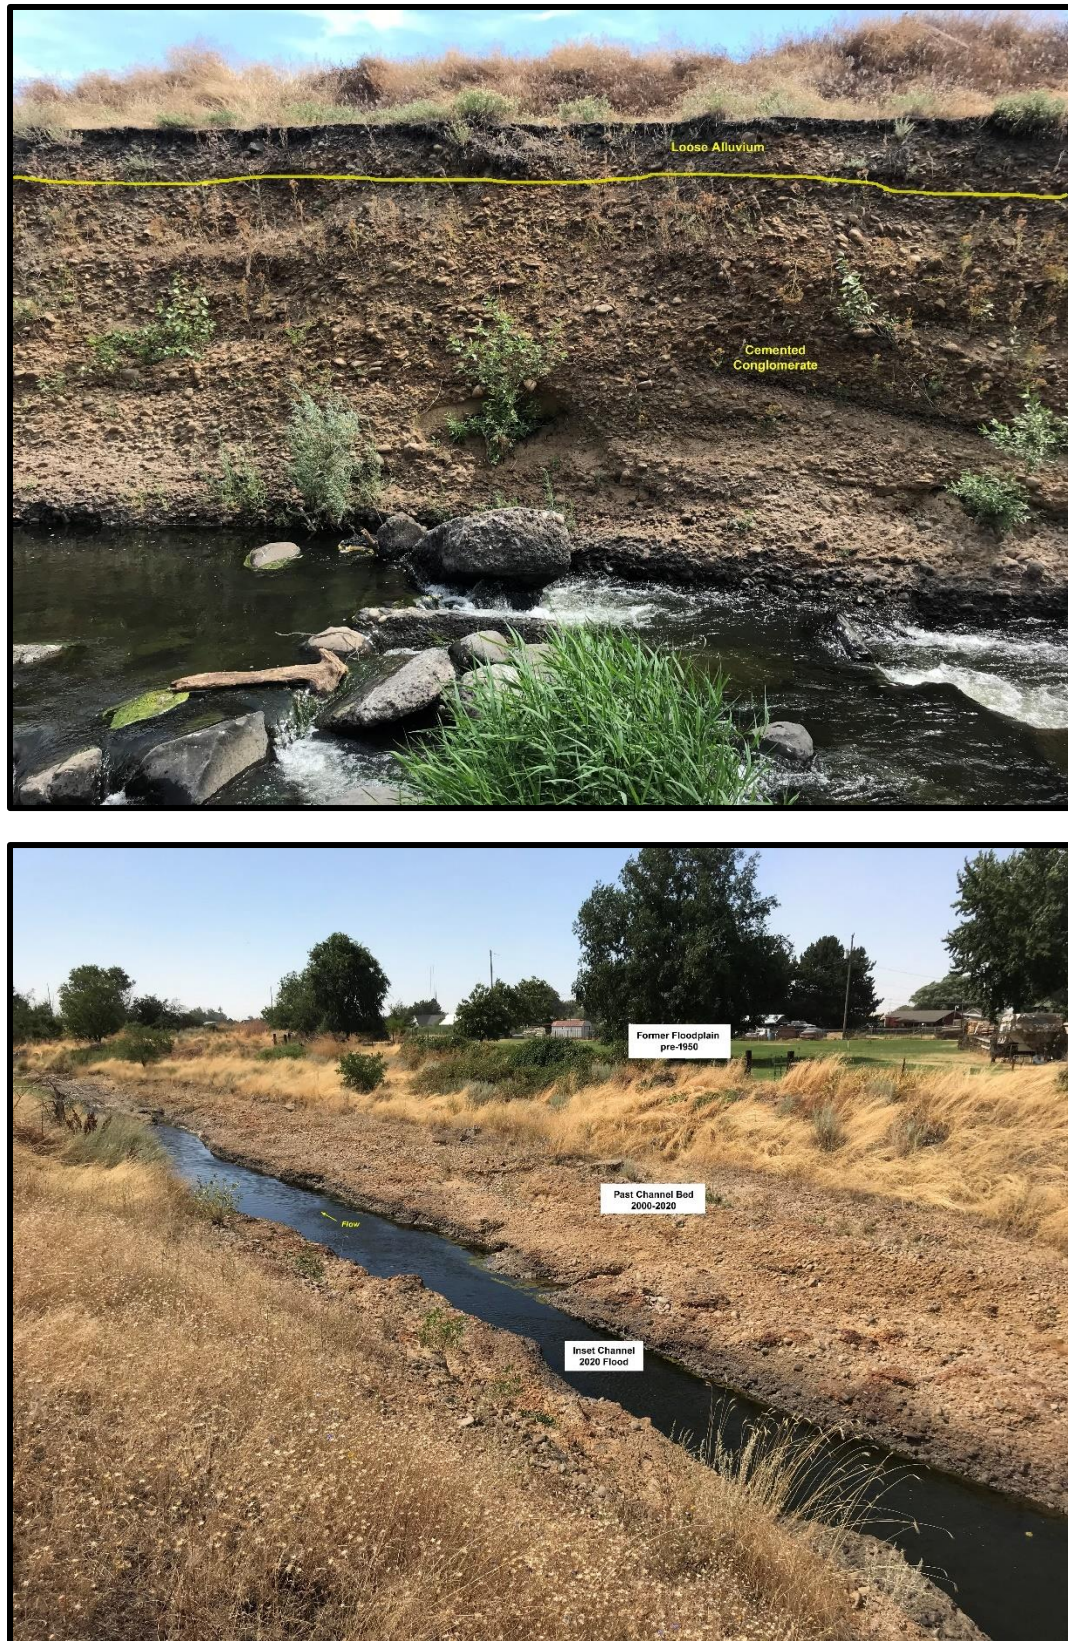
Figure 18. Alluvial deposits and former floodplain height on Mill Creek.

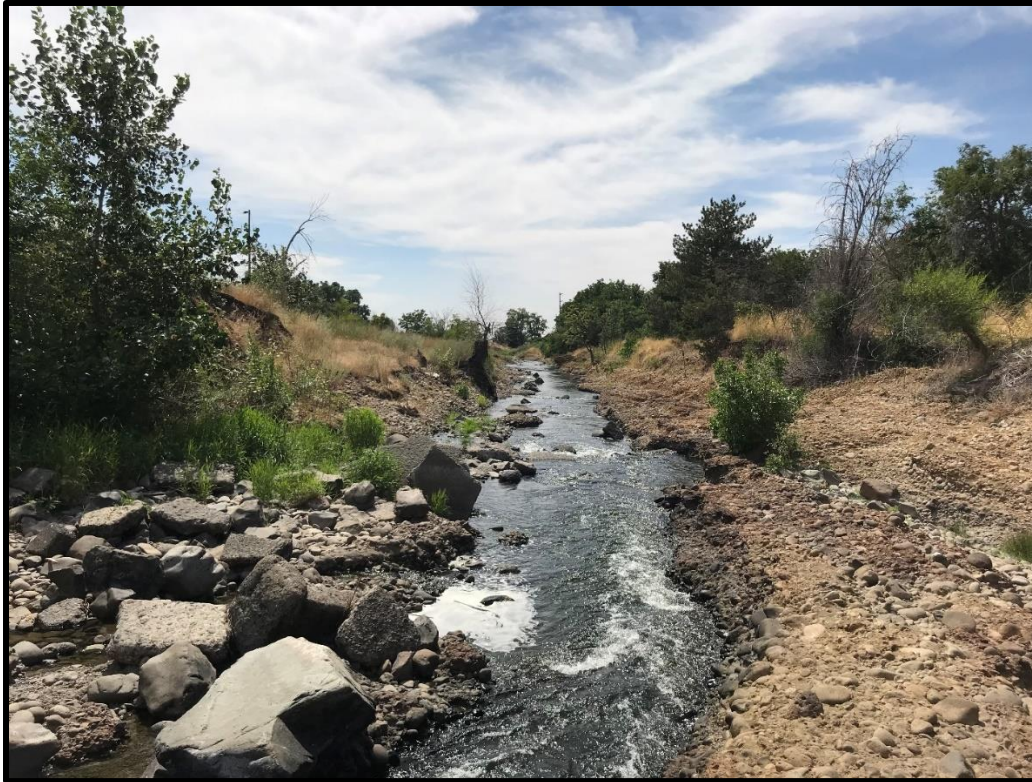
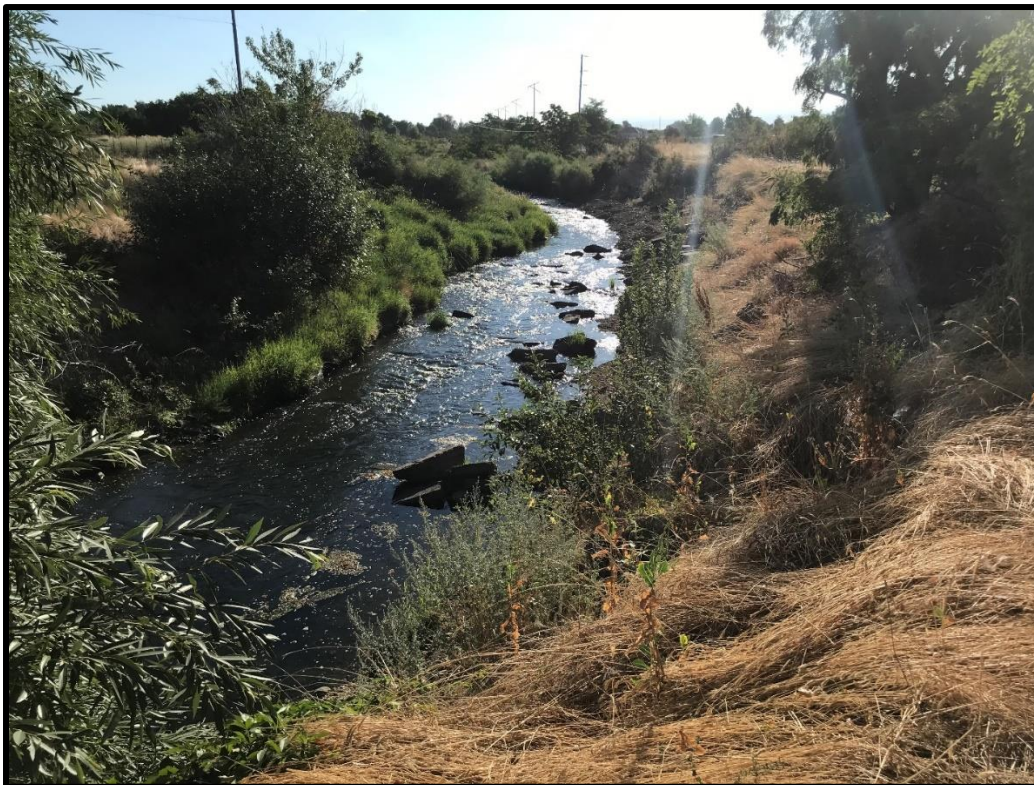
Figure 19. Looking downstream as Mill Creek flows toward the southwest and looking upstream from the Hussey Street bridge at the meander bend where the stream flows west.

Mill Creek becomes confined by floodplain terraces as it bends to the southwest (Figure 19). The channel edge includes small boulders and chunks of concrete, but no gravel bars are present. Very little vegetation is present along the channel, except for grasses and small shrubs. Two older floodplain terraces were observed on the left bank of the channel, with a corresponding floodplain terrace on the right bank of the channel. The channel bends back to the west as it approaches the Hussey Street crossing (Figure 19). The channel is well confined by cemented conglomerate banks that are about 10 feet high. The right bank includes more shrubby vegetation and reed canary grass, while the left bank includes some willow shrubs. Concrete rubble and old angular rip-rap boulders are present in the channel, but the channel bed still consists primarily of cemented conglomerate.

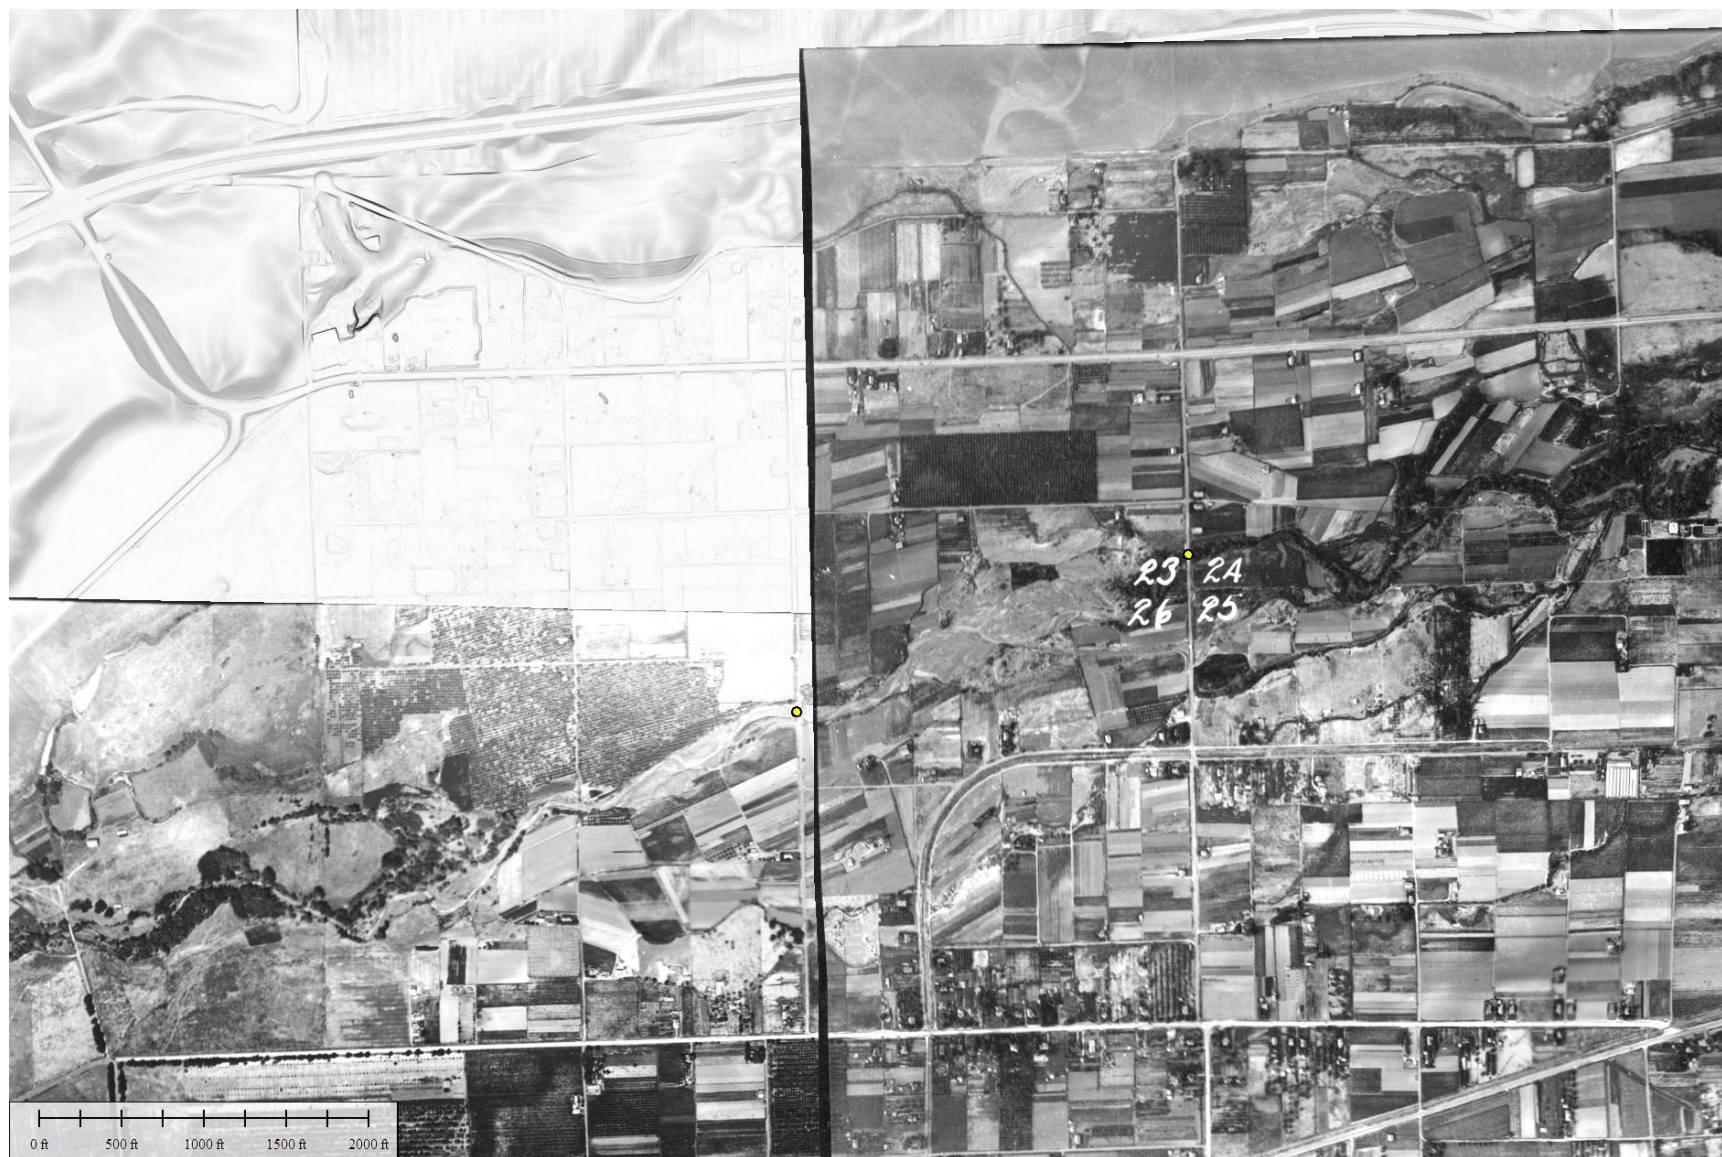
Figure A-1. Rectified 1939 aerial photographs highlighting the Gose and Hussey Street crossings (yellow dots) of Mill Creek.

The earliest aerial photographs from 1939 are the only historical documentation of Mill Creek channel and floodplain conditions prior to construction of the flood control project during the 1940s (Figure 7). The area above the Gose Street crossing of Mill Creek closely matches the 1938 survey with unvegetated gravel bars around the two branches of the overflow channel. An island of cultivated fields can also be clearly seen between the mainstem and overflow channels, but a band of riparian vegetation is still present along most of the channel length. Downstream of the Gose Street crossing, the mainstem channel heads south for about 500 feet before flowing out onto a broad, largely unvegetated floodplain area approximately 800 feet in width. The mainstem channel becomes multi-threaded, and evidence of side channels and older channel scars can be seen in the largely uncultivated area (Figure 7). Mill Creek flows for about 1,500 feet through the broad channel migration zone before the channel becomes more confined and single-threaded. The active channel area narrows down to about 100 feet in width as it reaches the Hussey Street crossing. Overlaying the historical mapped channel locations with the 1939 aerial photographs highlights the broad expanse of floodplain occupied by Mill Creek and the high frequency of channel avulsions during this time (Figure 8). The high sediment load carried through this reach of Mill Creek is readily apparent in the broad area of unvegetated gravel bars at the overflow channel confluence upstream of the Gose Street crossing and the multi-threaded channel downstream of the crossing.

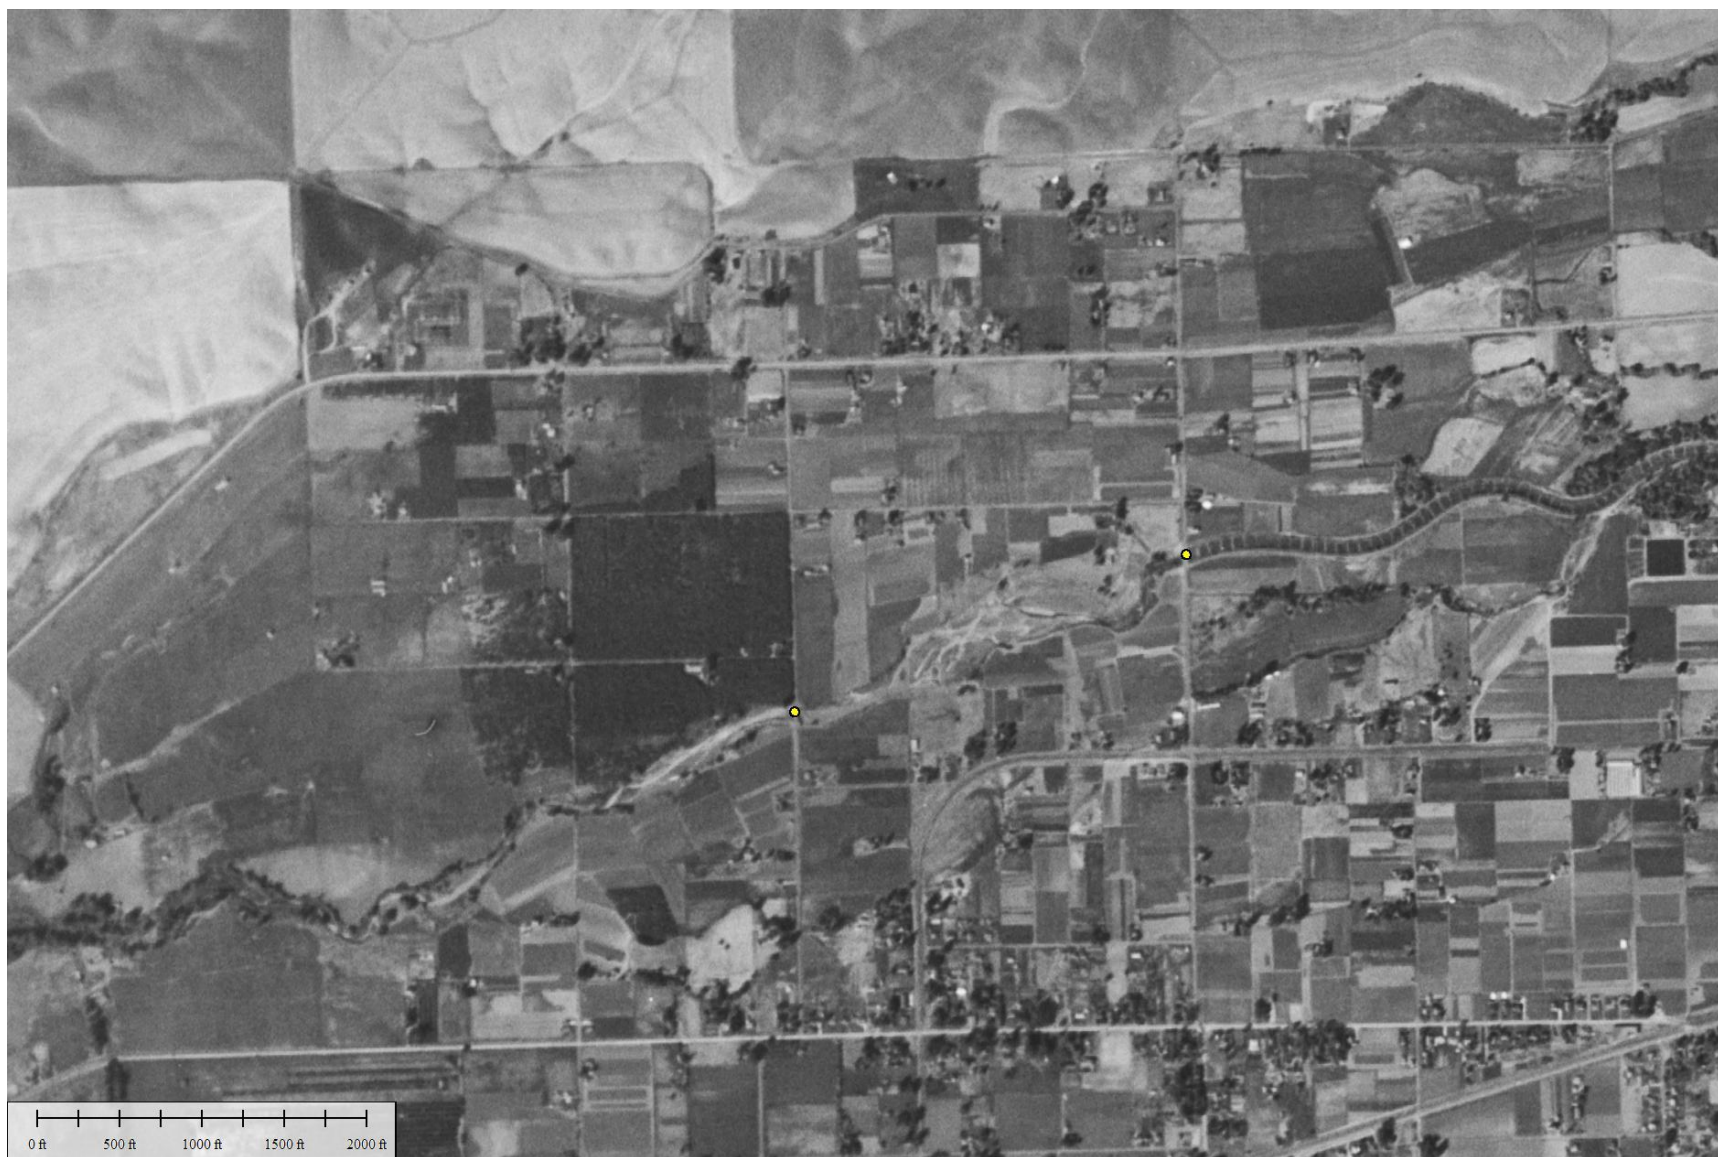
Figure A-2. Rectified 1952 aerial photographs highlighting the Gose and Hussey Street crossings (yellow dots) of Mill Creek.

As the stream enters the wide floodplain reach at about Station 20+00, the 1952 aerial photograph shows Mill Creek flowing on the right bank floodplain surface. The current elevation of the floodplain terrace at Station 15+00 is approximately 791 feet. The 2018 bare-earth LiDAR indicates a channel bed elevation of 781 feet, while the 2021 survey shows current bed elevations at 776 feet. About 15 feet of incision has occurred at this point relative to historical conditions. The lower end of the wide floodplain area at Station 9+00 has another terrace on the right bank where Mill Creek was located in 1952 at an elevation of 785 feet (Figure 21). The 2018 bare-earth LiDAR indicates a channel bed elevation of 776 feet, while the 2021 survey shows current bed elevations at 772 feet. About 13 feet of incision has occurred at this point relative to historical conditions.

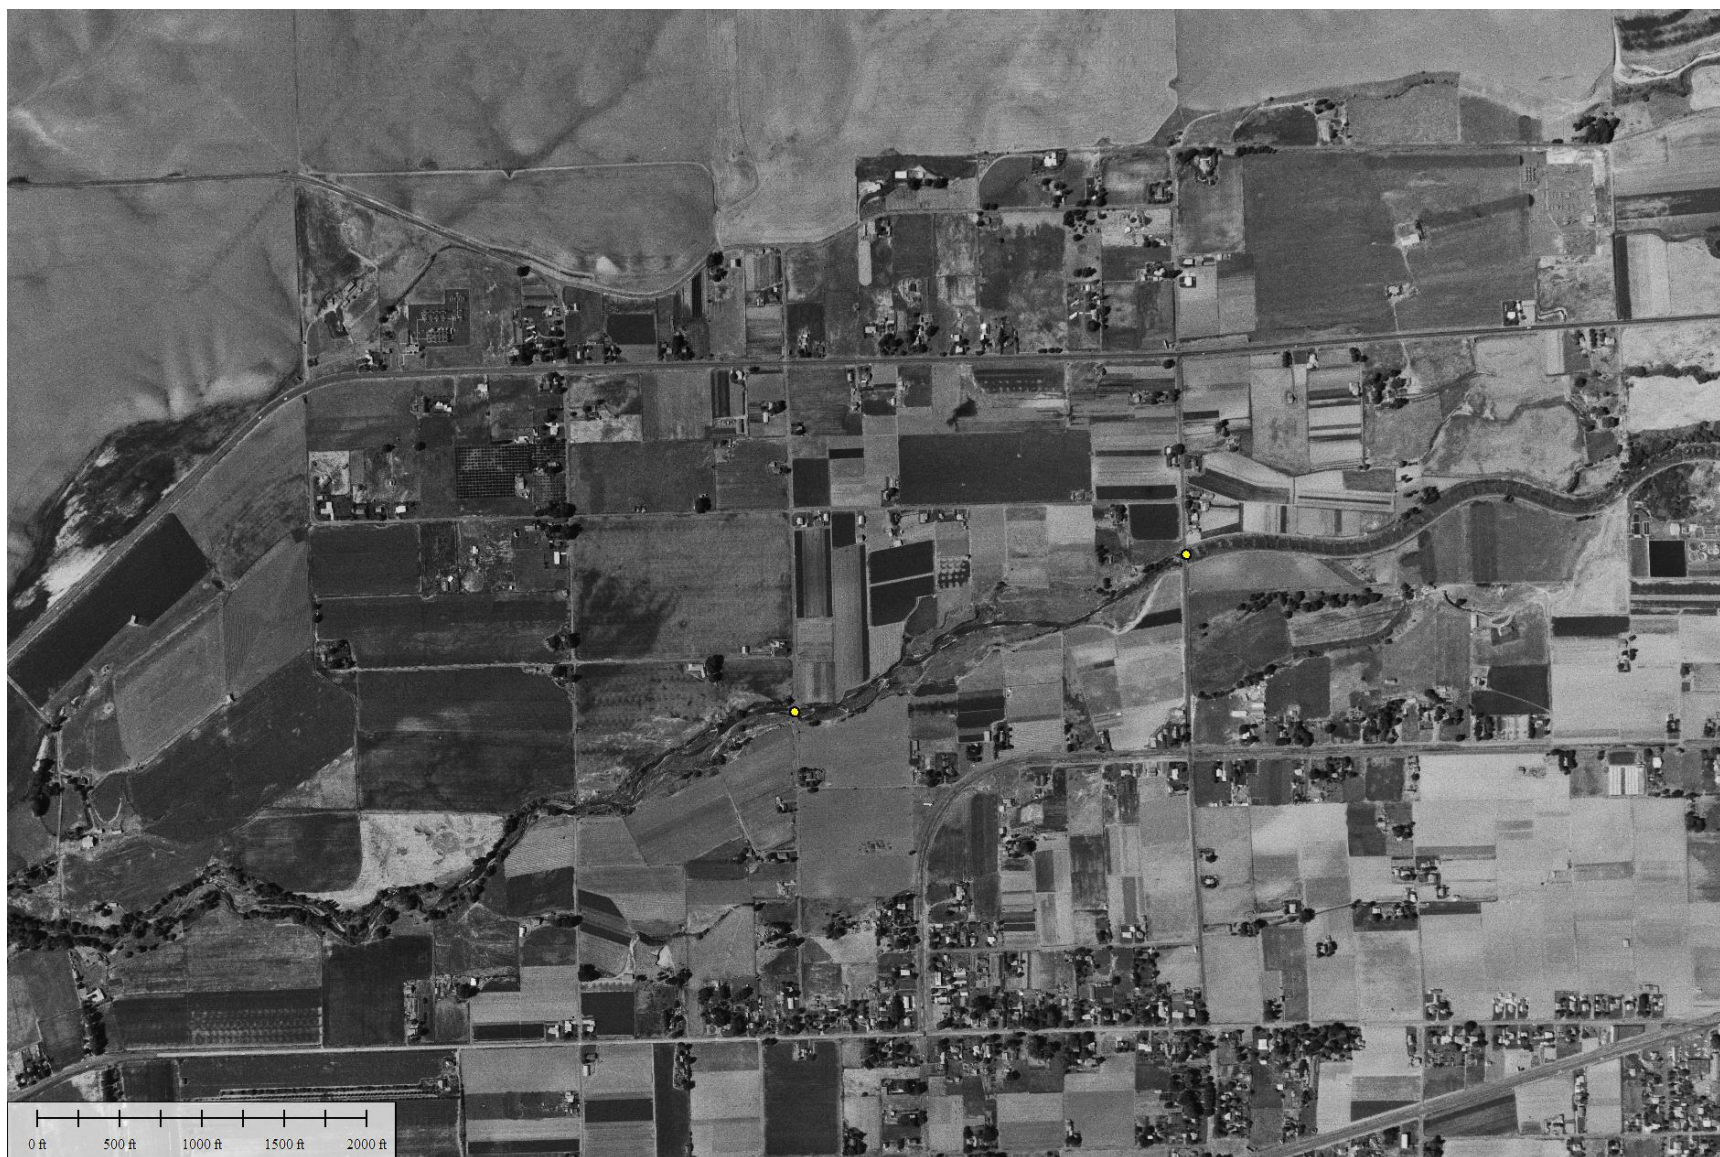
Figure A-4. Rectified 1964 aerial photographs highlighting the Gose and Hussey Street crossings (yellow dots) of Mill Creek.

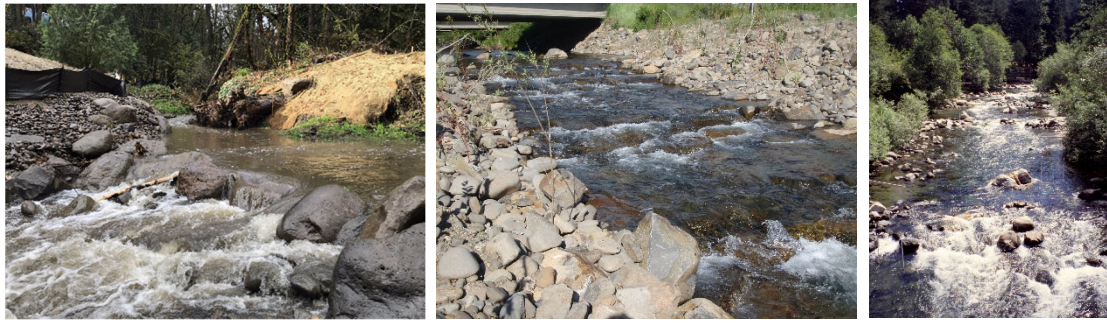
Figure 6 – Example photos showing (from left to right), showing Nature-like Fishways a boulder riffle and roughened channel and a series of boulder drops.

The new fishway width would be 26 feet with 13-foot-long pools. The floodplain of the channel would be widened to 50 feet (currently the channel is 25 feet wide), with 2:1 side slopes on the left bank. Wing walls and rock riprap would be used to backfill to the top of the walls. The drop at each weir would be 0.8 feet, so the overall slope of the fishway would be 6.2 percent. This would leave a 3-foot drop at the downstream end of the fishway which would be the starting point for the channel downstream. The fishway width, drop, length and slope were optimized based on monitoring results by the author of the existing Pool and Chute Fishway and others built in Washington and California. Then, starting at a distance of 60 feet downstream of this new fishway an 800-foot-long Nature-like Fishway would be constructed. The slope of the channel would be 1.4 percent. The channel would be widened to 50 feet.

Cut-off walls to seal the bed would be on average three feet high and countersunk one foot into the channel bed to create a low water seal. The length of the cut-off walls would vary from 20 to 30 feet. The constructed riffles would be spaced 55 feet with a drop of 0.8 feet for an average slope of 1.4 percent. Depending on modeling results the drop or riffle would include a cut-off wall which would be either 1) a concrete weir, 2) a concrete box filled with boulders to form a riffle (rocks in a box), or 3) boulder weirs to form a roughened channel (Figure 6). Most likely the design would have either a concrete or sheet pile weir buried underneath boulders and cobble ranging in size from 4 feet to 6 inches. After the cut-off walls are placed the channel would be filled with existing material excavated from the bank. The top 3 to 4 feet would be an imported roughened channel mix to form the channel.

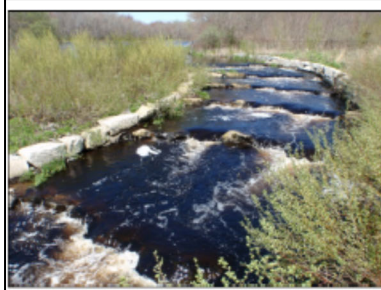
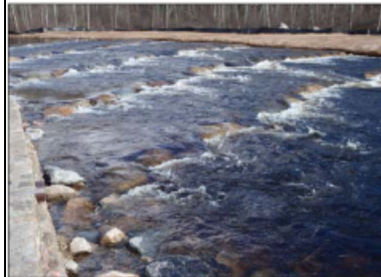
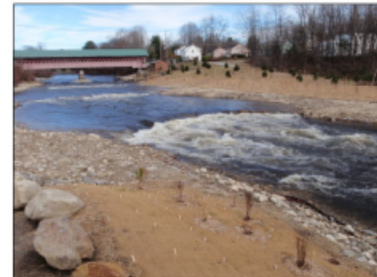
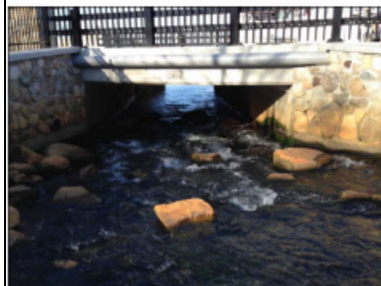
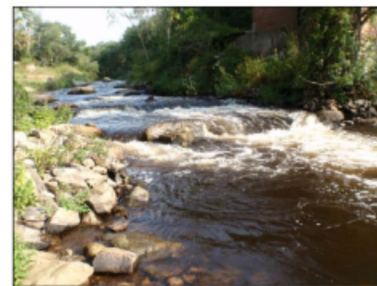
Saw Mill Park step-pool fishway,
Acushnet River, Acushnet, MA

Fields Pond step-pool fishway,
Sedgeunkedunk Stream, Orrington, ME

Kenyon Mill step-pool fishway,
Pawcatuck River, Richmond, RI

Homestead dam removal and NLF cross-vanes,
Ashuelot River, West Swanzey, NH

Water Street tidal rock ramp,
Town Brook, Plymouth, MA

Lower Shannock Falls NLF weirs,
Pawcatuck River, Richmond, RI

Figure 7 – More examples of Nature-like Fishways from Federal Interagency Nature-like Fishway Design Guidelines, 2016.

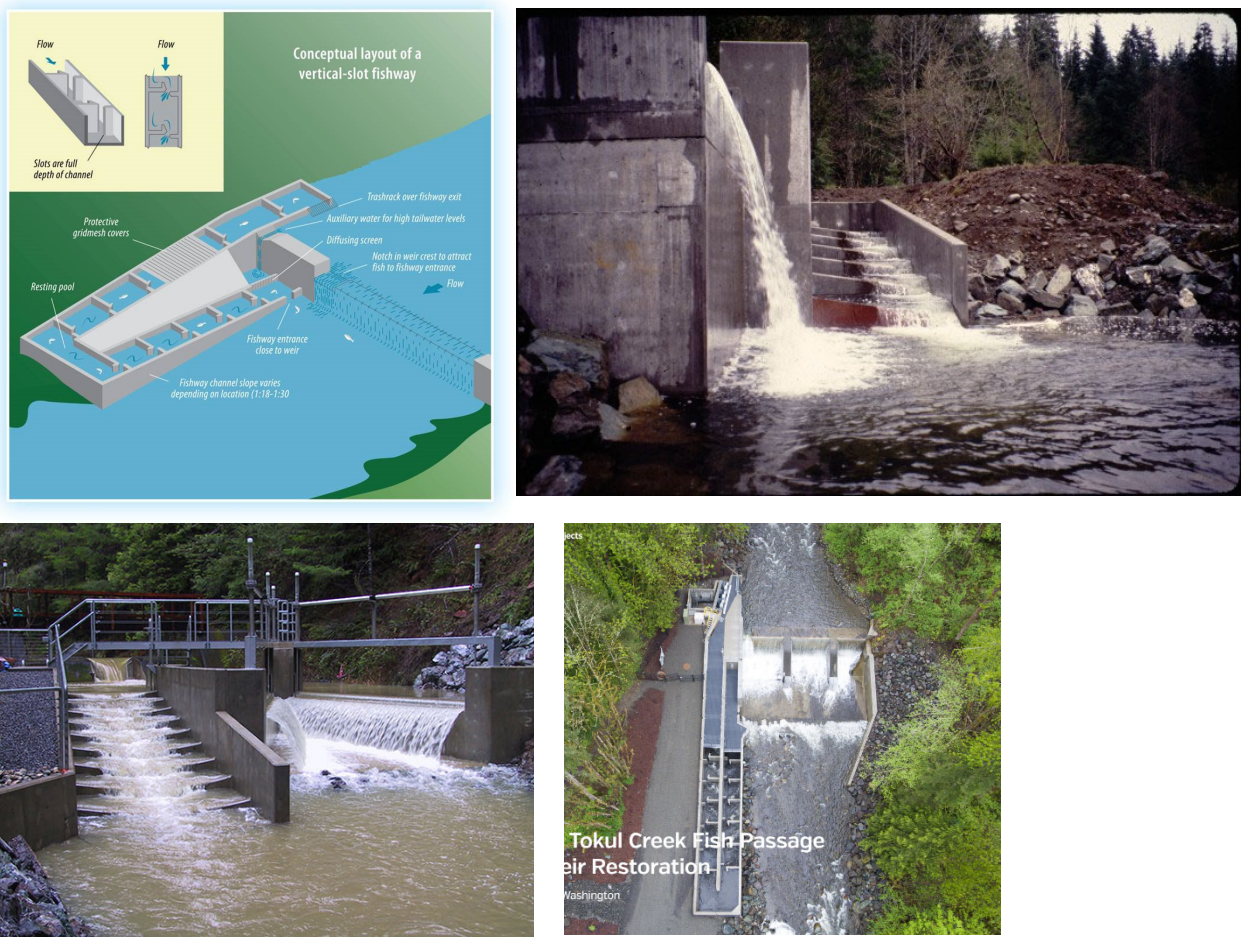
Figure 8 – Examples of Pool and Chute, Pool and Weir and Vertical Slot Fishways.

This Option would consist of building a 10 to 12-foot-high dam or weir across the channel at the downstream end of the existing fishway, which would backwater up to the pool under the bridge. The fishway would have 20 steps. The fishway type would be either a pool and weir or vertical slot. See Figure 8. The downstream end of the fishway would extend 3 to 4 feet below the existing bed to account for future channel incision and there would be a concrete stilling basin to dissipate the energy from the spill. This option would abandon the lower existing fishway under the bridge. Fish would exit the fishway into a deep-water pocket under the existing bridge.
